# Local Perfusion Failure Caused by the Incorrect Attachment of an SpO<sub>2</sub> Sensor During General Anesthesia

Anesth Prog 72:49–50 2025 | DOI 10.2344/24-0022

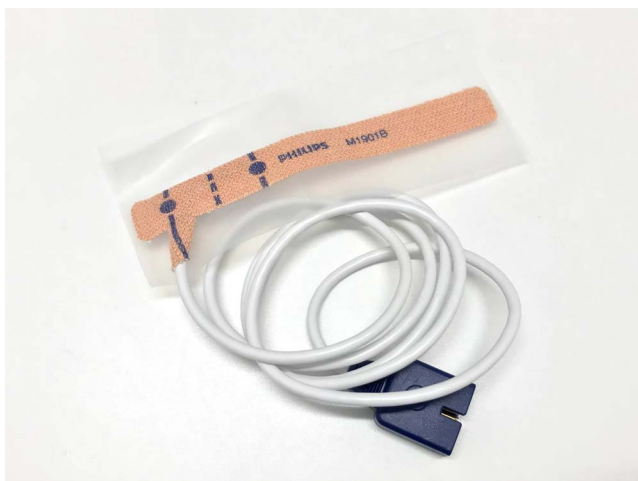
**Figure.** Pulse Oximeter Probe Used in the Case

This pulse oximeter probe features adhesive tape designed to help probe retention on the patient's finger.

Because the pulse oximeter sensor was strongly suspected to be malfunctioning, the patient's fingers were evaluated, at which time it was noted that the finger on which the sensor was attached was discolored. When another pulse oximeter sensor was applied to different sites on the same side (ie, left

toe and middle finger), the SpO<sub>2</sub> readings were confirmed to be 100%. It is likely that the adhesive tape was simply too tight, causing excessive pressure and resulting in hypoperfusion as the case progressed. This situation was also likely exacerbated by the lower blood pressures during the case, resulting in inaccurate SpO<sub>2</sub> readings.

In cases of suspected pulse oximeter abnormalities, checking the sensor position and the general condition of the tissues where it is attached is crucial, particularly in young patients. Furthermore, when diagnosing a pulse oximeter abnormality, it is important to comprehensively evaluate capnography and other anesthetic monitors for problems while also reviewing the patient's vital signs, such as blood pressure and pulse rate. Considerations for obtaining an arterial blood gas analysis may also be indicated. If an abnormal SpO<sub>2</sub> value is detected, the first thing that should be done is to verify the fit and positioning of the pulse oximeter probe. When applying the pulse oximeter tape-type probe, it is important not to wrap the tape too tightly.
